NACA RM E55H12

INVESTIGATION OF A CERMET GAS-TURBINE-BLADE MATERIAL
OF TITANIUM CARBIDE INFILTRATED WITH HASTALLOY C

By Charles A. Hoffman

January 24, 1956

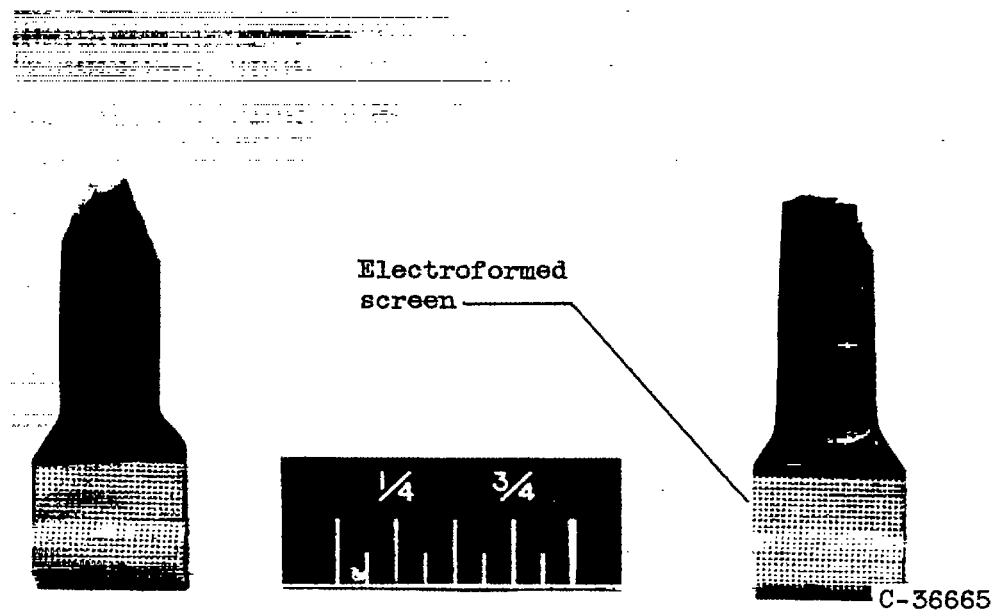
A comparison of the performance of the cermet blades with that of the control alloy blades shows that both types of blade were damaged by impact. Cermet blades 6 and 7 withstood repeated impact (fig. 3) without catastrophic failure. Although the airfoil mass of these blades was reduced by chips removed by impact, the total reduction in mass was not great, and the effect upon blade centrifugal stress was not believed appreciable. The cermet blades, however, tended to undergo catastrophic failure upon impact. The alloy control blades, on the other hand, generally appeared better able to resist impact (fig. 11); these blades were nicked and their edges were torn. This damage, however, was less extensive than that of the cermet blades.

Figure 3. - Impact damage to cermet turbine blades 6 and 7.

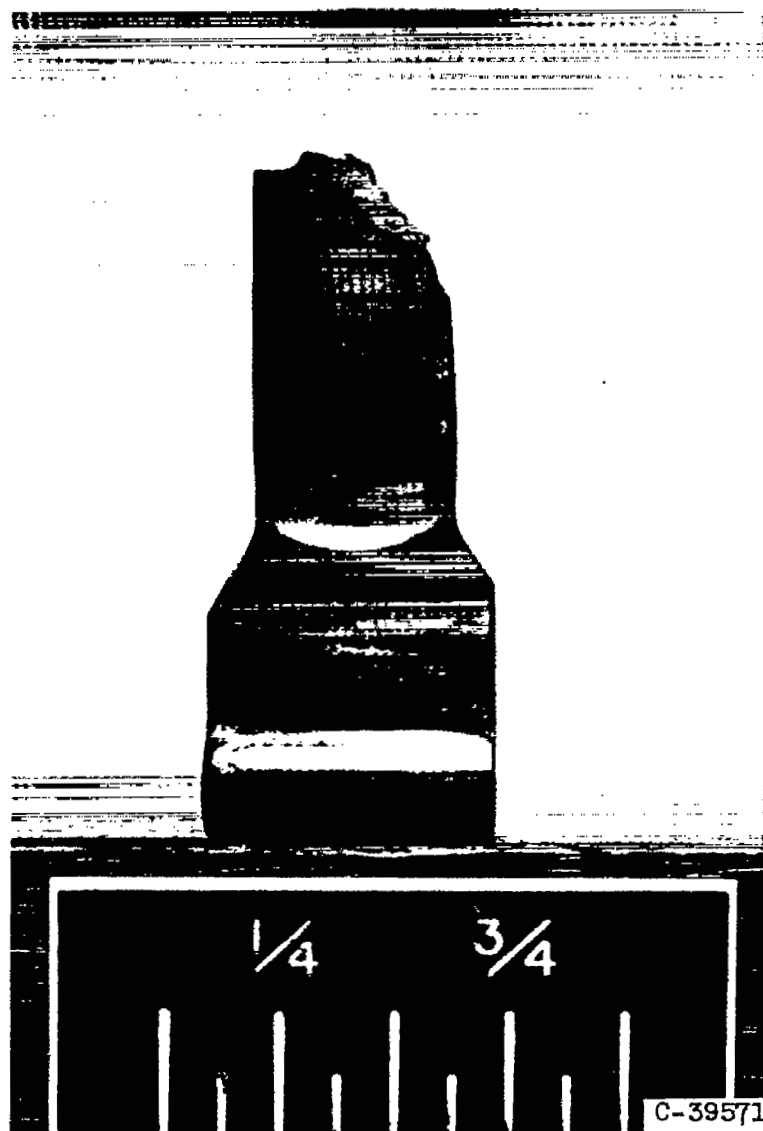
Description of failures. - A summary of engine operation is presented in table I. The simultaneous occurrence of a nearby wheel dovetail failure in the case of blade 1 and the appearance of blades 2 and 4 after failure indicate that these three failures were caused by impact. The failure in the base of blade 1 occurred completely across the neck just above the neck-roll juncture. The airfoil failure due to impact of blade 2 is shown in figure 6. This failure is similar in appearance to that of blade 4.

Figure 6. - Cermet turbine blade 2 after failure caused by impact.

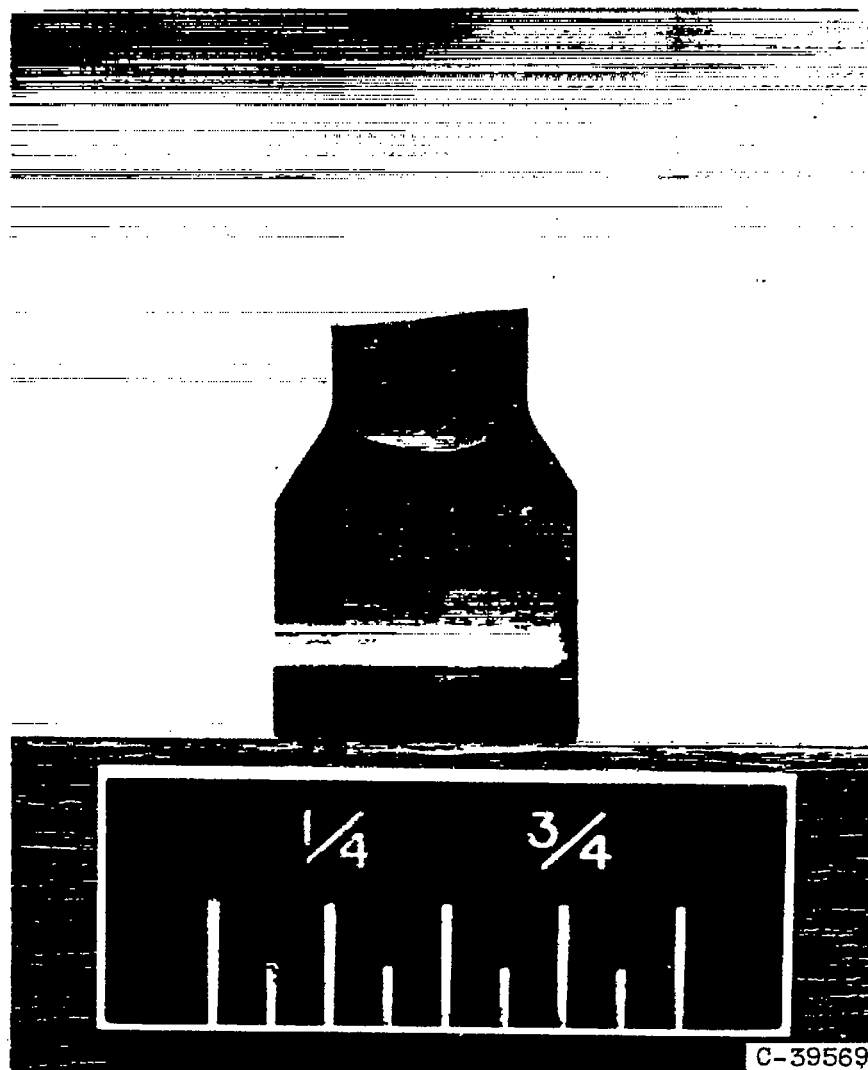
Blades 6 (fig. 7) and 7 failed at about midspan along with the failure of several short metal blades. Previous experience with alloy blades indicates that the failure of the airfoil of either cermet blade would not be expected to set up sufficient vibration to cause the failure of metal blades. Hence, it appears likely that the alloy blades failed first and caused cermet blade failure by impact or excessive vibration. In the case of blade 7, the possibility that failure occurred by impact was strengthened by the observation that the blade was chipped (fig. 8). In either blade, there is also the possibility of failure due to normal stresses.

Figure 7. - Midspan failure of cermet turbine blade 6.

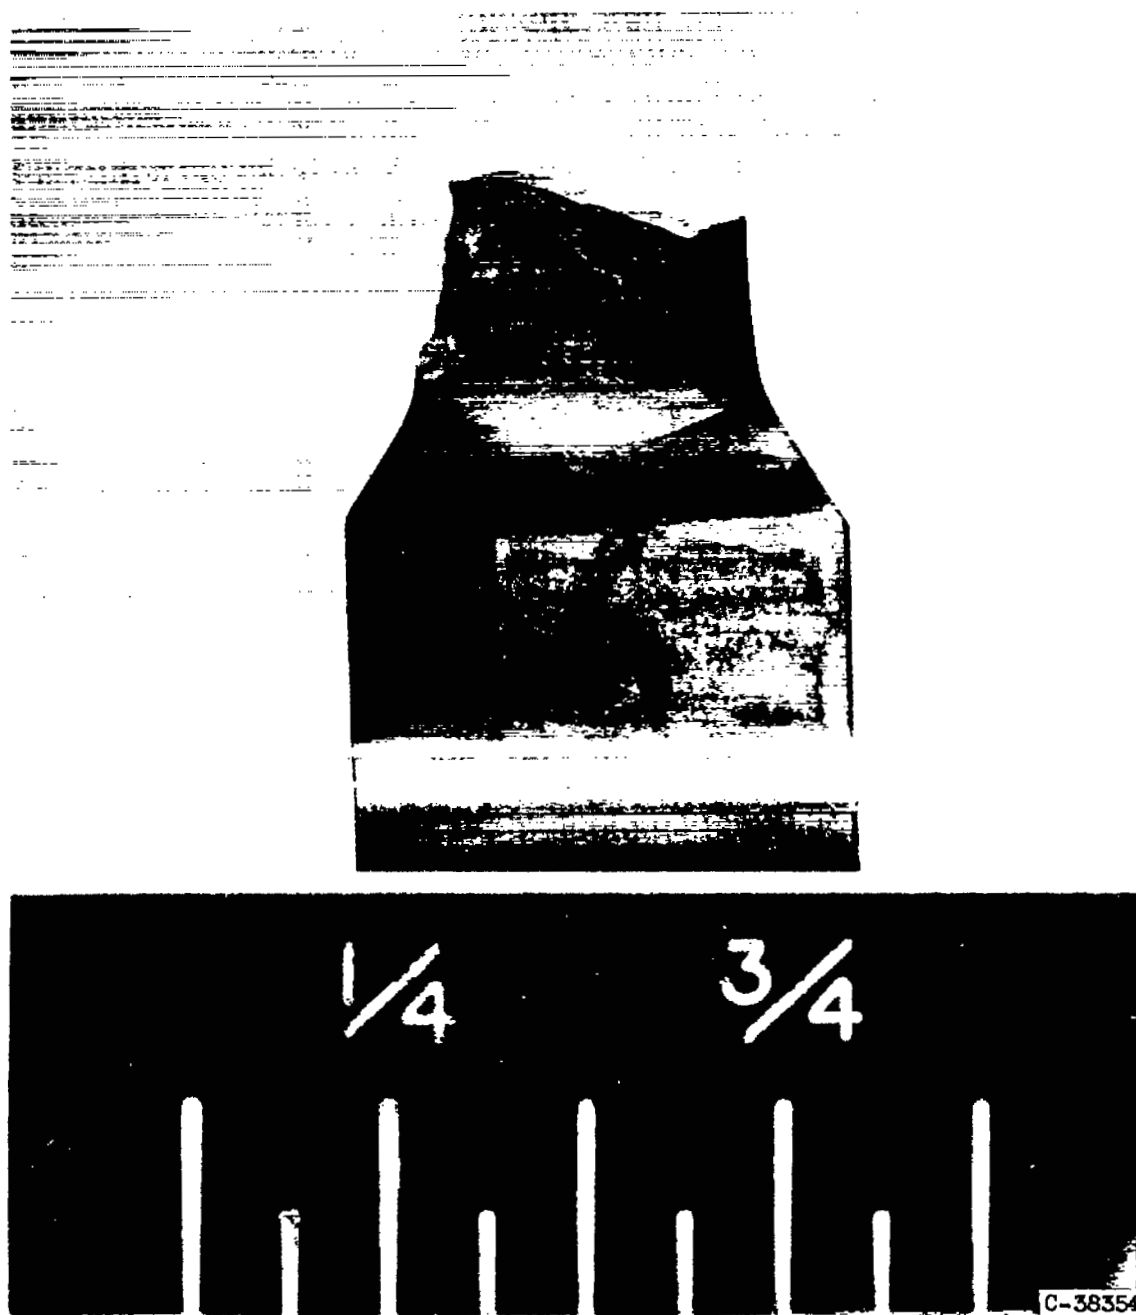
Figure 8. - Cermet blade 7, which may have failed by impact.

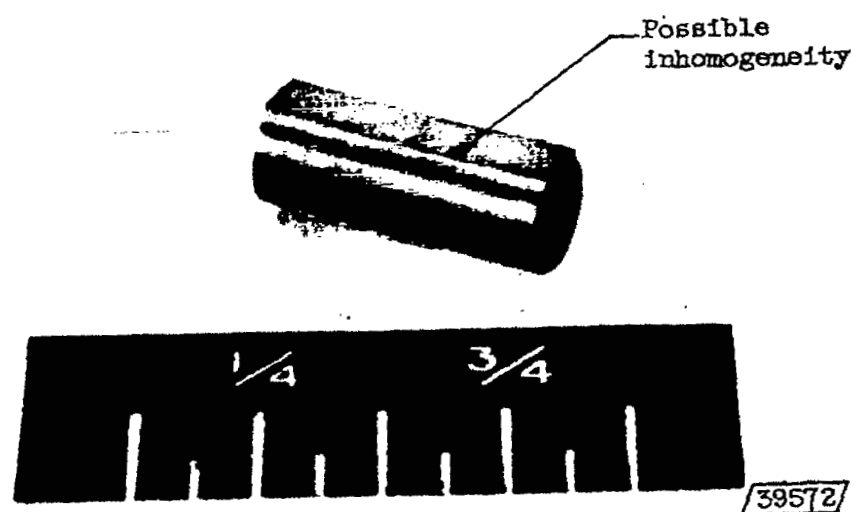
The failure of cermet blade 5 in the base at the juncture of the neck and the roll (fig. 10) in a manner similar to the failures in blades of other cermet compositions (refs. 3 and 5) may have been due to stress concentration effects. The unusually short time to failure suggested that this blade might have also failed as a result of a structural flaw. Inspection of the failure revealed a possible zone of inhomogeneity.

Figure 10. - Failure of cermet blade 5 at juncture of neck and roll.

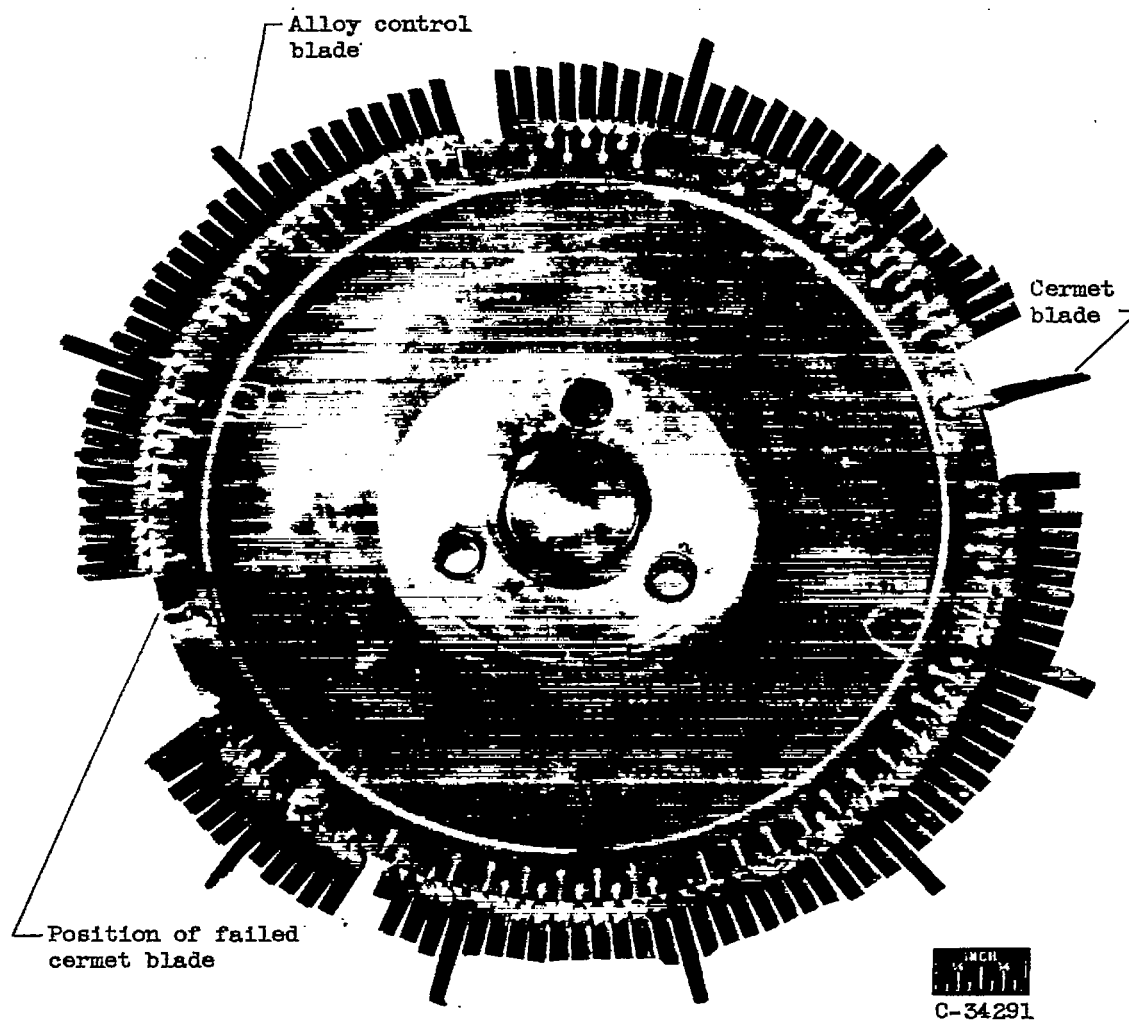
Figure 11. - Rear view of wheel 1 after failure of cermet blade 3.
